Mechanism of Degradation of Bismaleimide (BMI) Composites due to Galvanic Reactions Between Metals and Carbon Fiber

JCAMS 2024

Prepared By: Dr. Luis A. Valentín Marrero

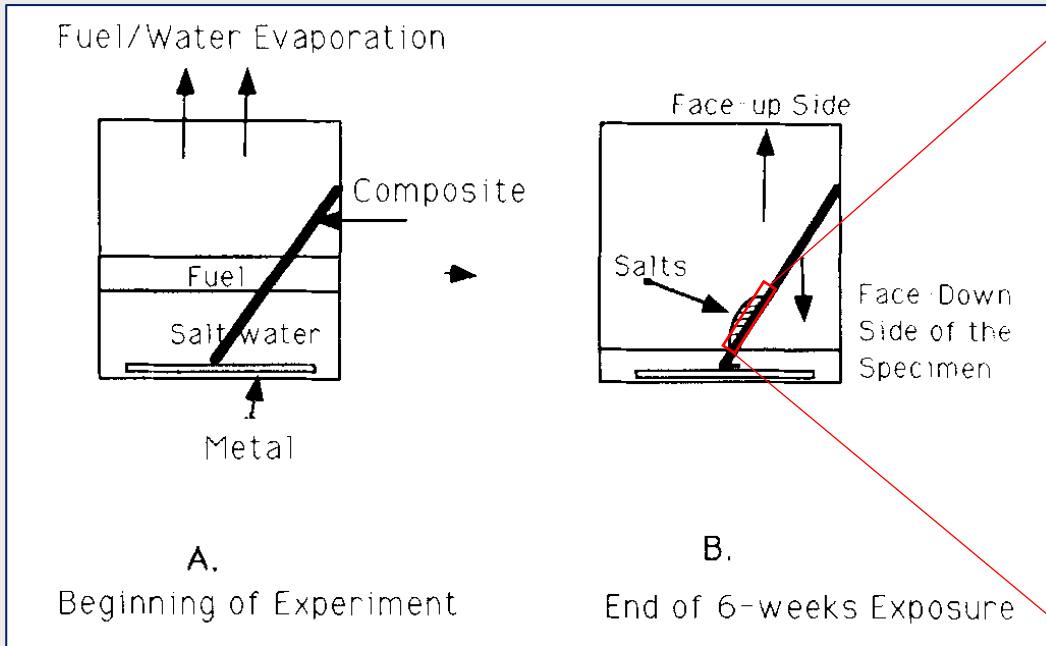
BMI surface

- The aggregation of salts favor the OH^- buildup, which then initiates attacks on **cyclic imide structure**. The presence of moisture and salts and conductive contacts between unprotected metals and imide-type (BMI) carbon fiber composites have been known to constitute the prerequisite conditions for imide-type composite degradation.
- Degradation was found to invariably progress more heavily on the face-up side of the BMI specimens where the white sludges (in the aluminum-composite setup) were deposited.

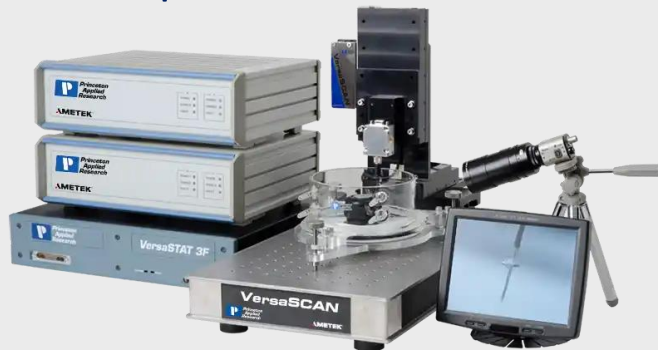
Analytical method used to establish the electrochemical response of a corrosion cell over a wide range of frequencies. This response includes properties such as impedance, capacitance and phase angle.

- Used extensively by the coatings industry to measure the efficiency of corrosion-prevention coatings applied to metal substrates.
- Changes in current flow are strongly associated with changes in reaction rate (i.e., corrosion rate) when chemical reactions are taking place in both anode and cathode regions of the electrochemical system.
- Phase angle results are very descriptive of polymer degradation within the galvanic couple.
