# Advanced ultrasonic testing on helicopter blades and aircraft structures

JCAMS Presentation

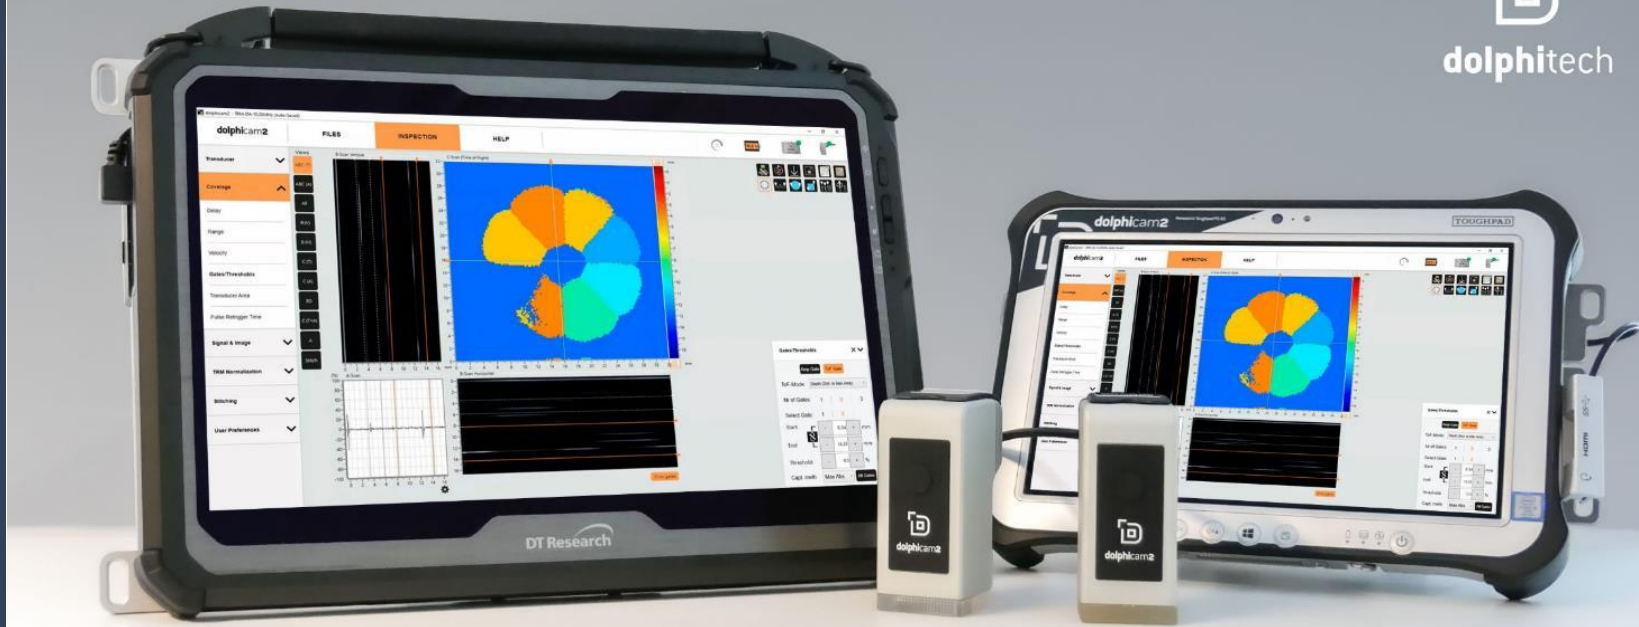
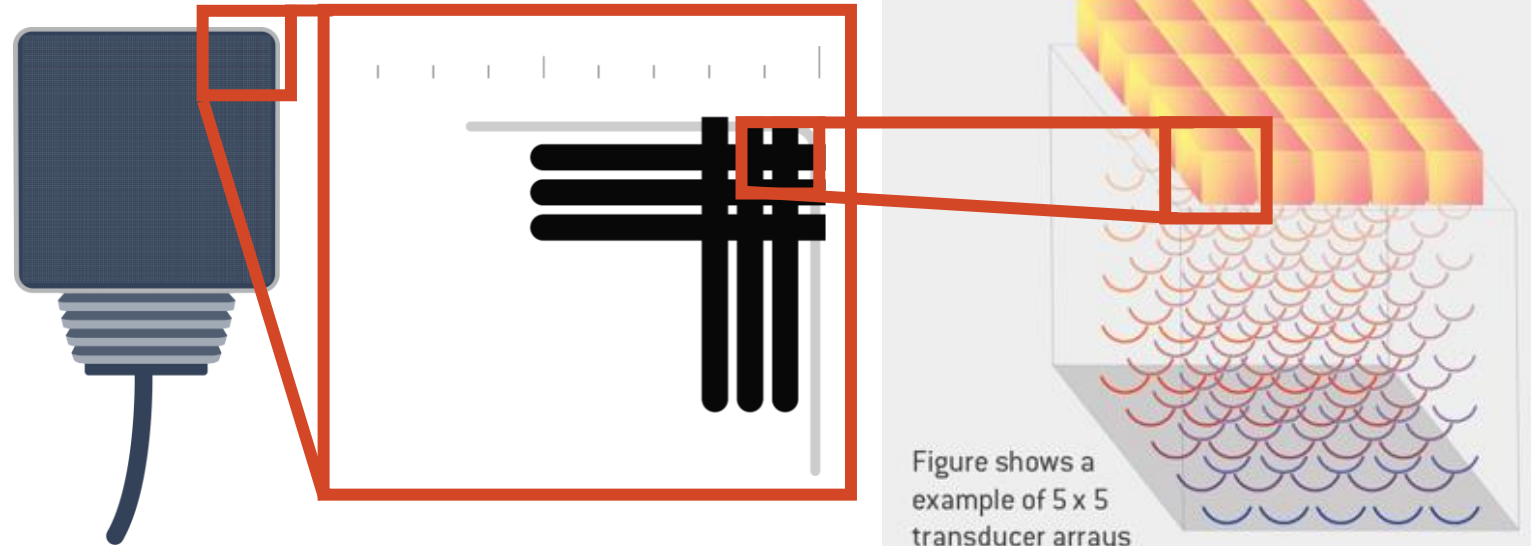
- Unique 2D matrix array transducer platform
- Live data capture in 3-dimensions and high level of detail
- Transducer frequencies from 0.7 – 10MHz
- Inspection of CFRP, GFRP, metals, bonds and coatings
- Digital Twin compatible (MOSA\*)
- MAUT – ASTM E3370  
<https://www.astm.org/e3370-23.html>
- NATO stock number NSN 6635-20-A0Z-0556

Figure shows a  
example of 5 x 5  
transducer arrays

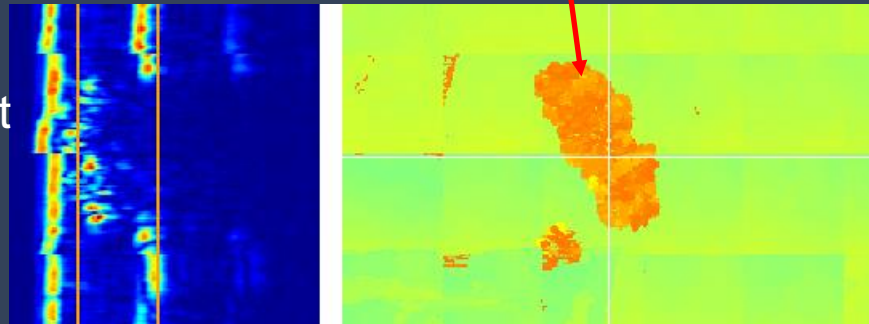
Delamination due to removal. Lower surface was adhered to the frame.

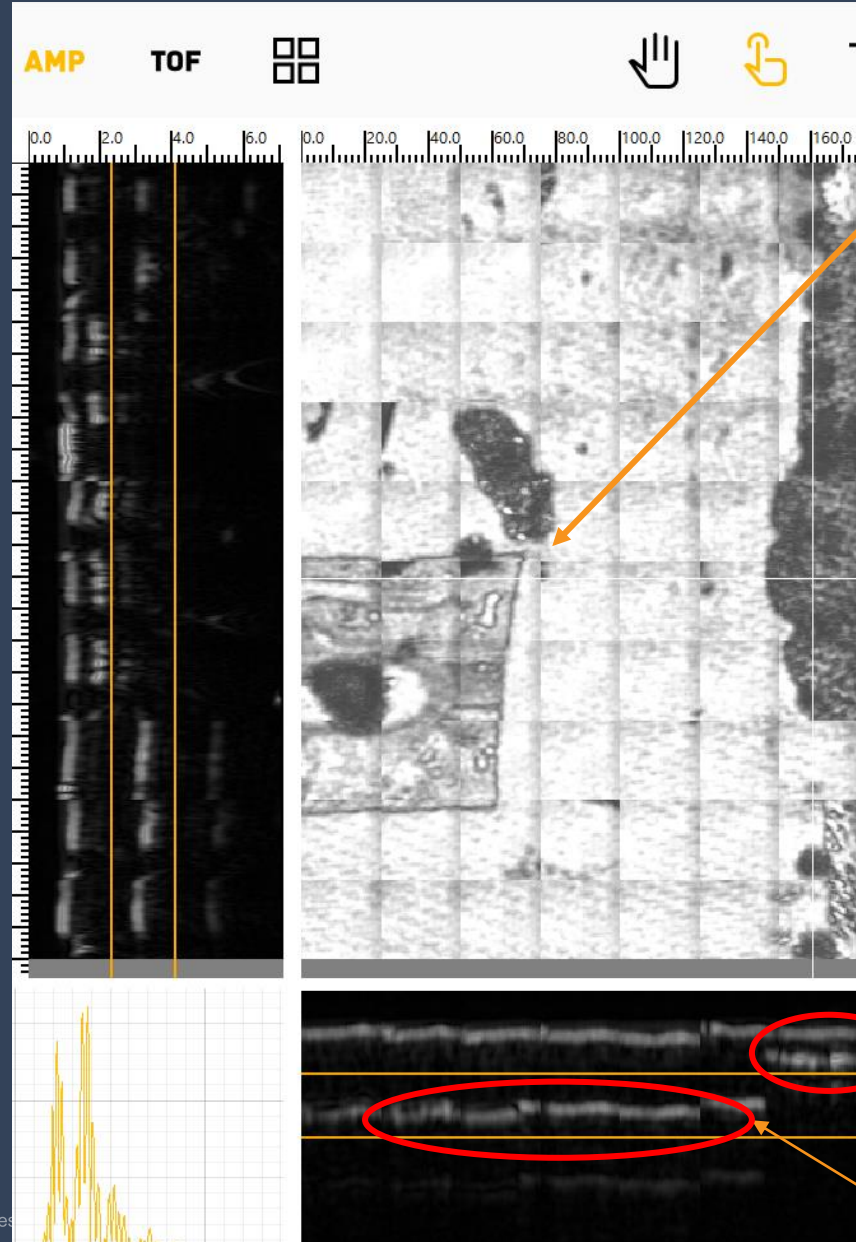
Three areas of delamination in the C-Scan view with accompanying B-Scan data view.

Tape can clearly be seen in amplitude view

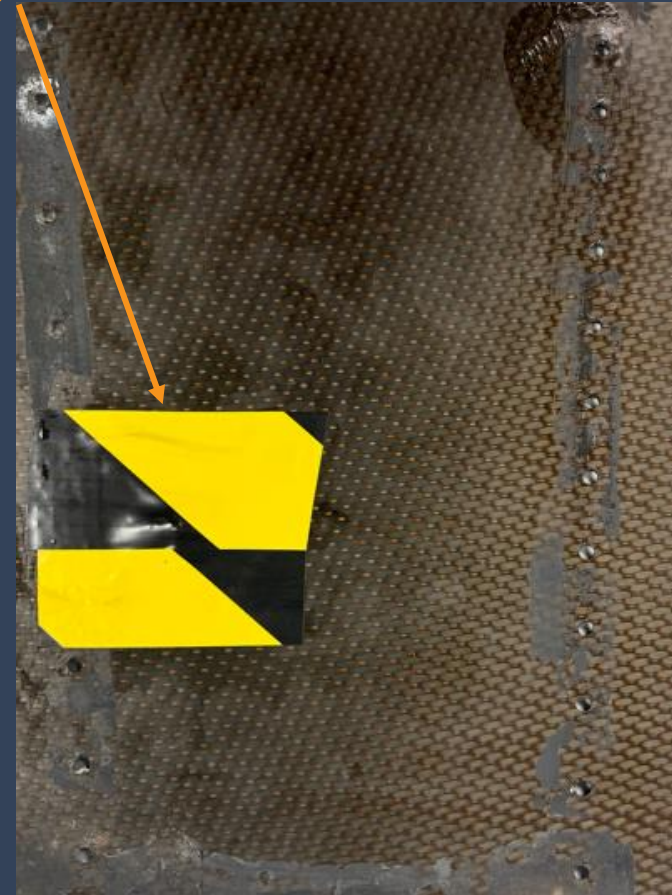
Delamination near surface.

Back wall echo.

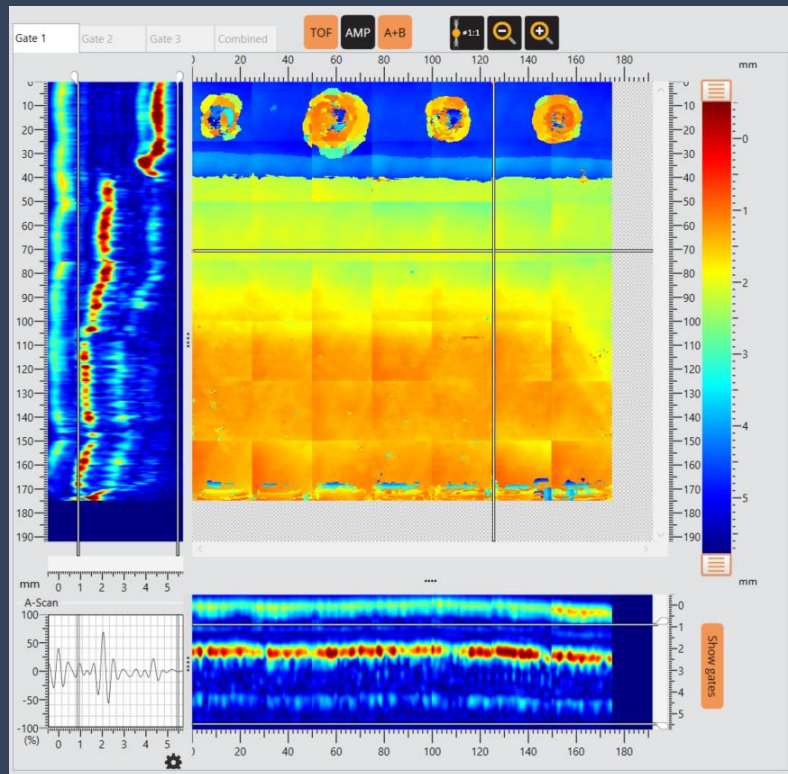
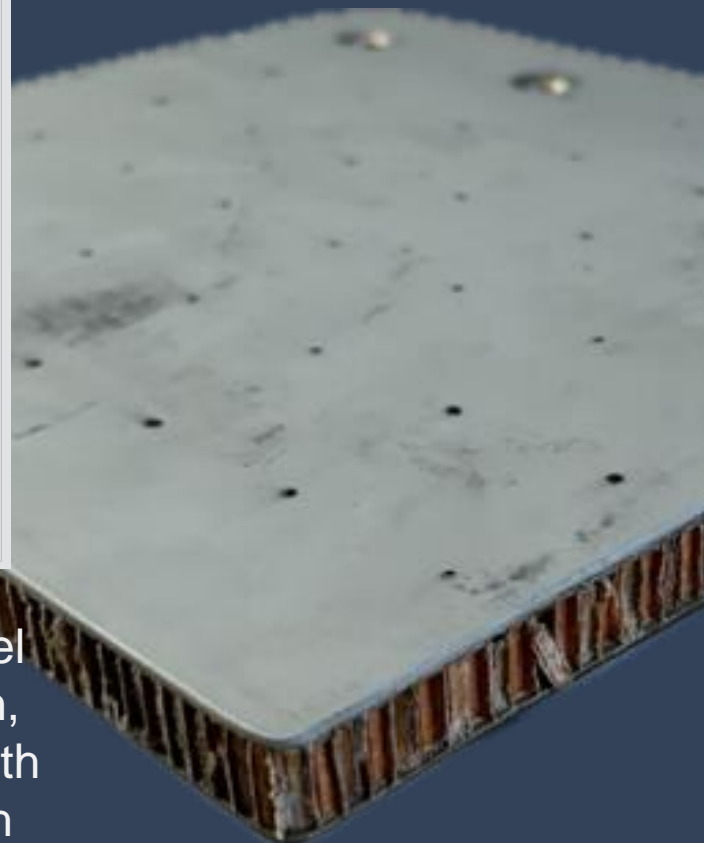
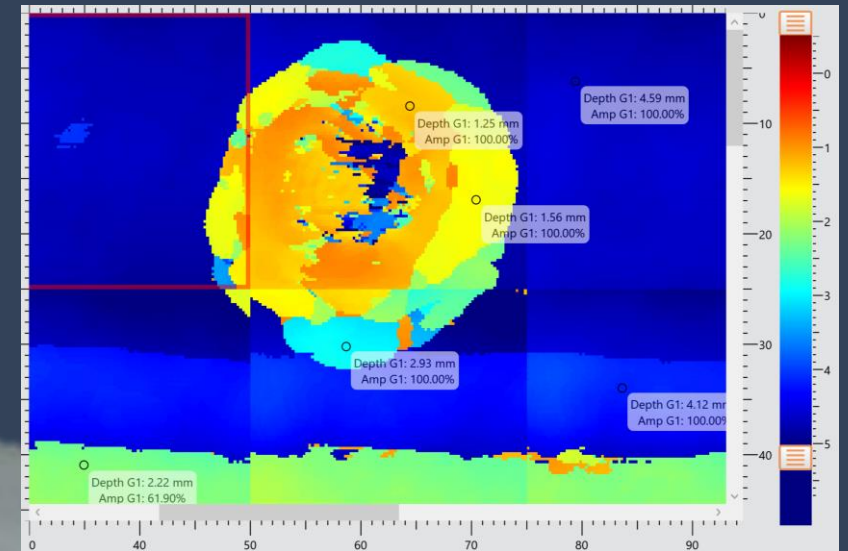
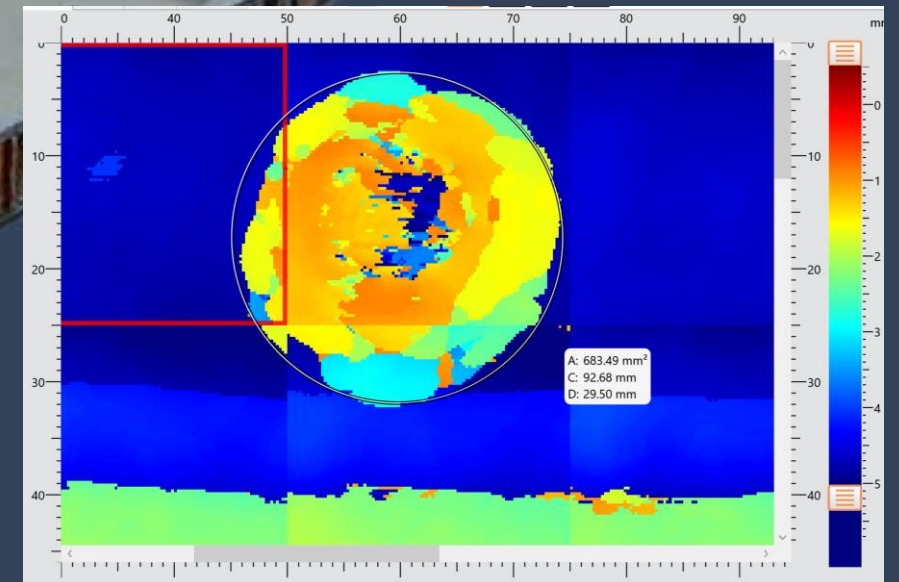
Multi-layer delamination due to panel fasteners being over torqued. Depth, area, amplitude are all measured with accuracy. Image fully integrated with reporting tool.

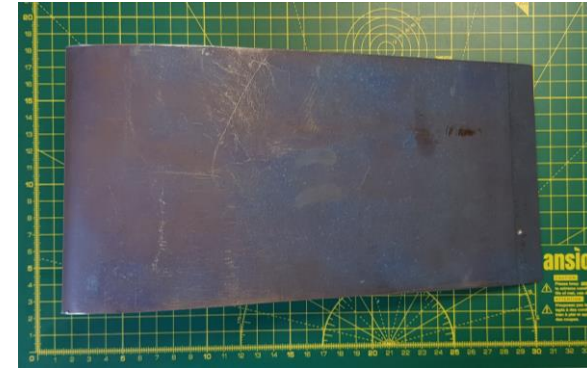
Top

- Diffusion-welded titanium control surface section.
- The dimensions of the part are approximately 11" x 5" x 3" (28 cm x 13 cm x 7 cm).
- The structure is hollow with the thickness of the skins changing throughout, from <math><0.4\text{''}</math> to <math>>1.2\text{''}</math> (<math><1\text{ mm}</math> to <math>>3\text{ mm}</math>) at the welded joints.
- Additionally, there are various ridges, indentations and drilled holes.

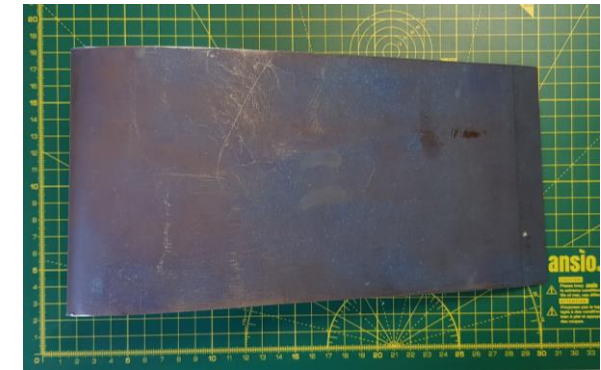
# Results: Encoded scan of top surface

- Shown is the amplitude view.
- Can see dark ridges in the C-scan as the profile of the sample varies.
- Can see the drilled hole on the bottom side as a dark circle in the C-scan (green box) and as a discontinuity in the back wall in the B-scan (green arrow).

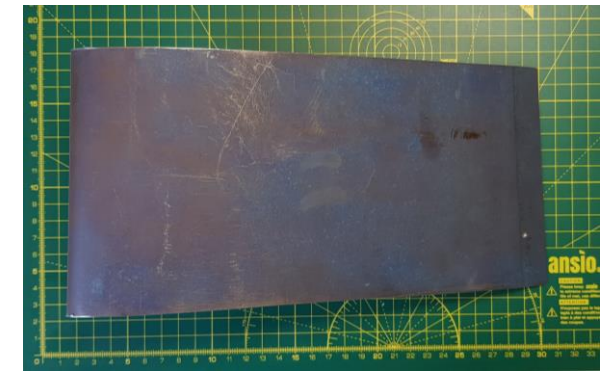
# Results: Encoded scan of top surface

- Shown is the thickness (ToF) counterpart.
- Can see the dark ridges in the amplitude scan are caused by variations in the thickness. For example, the skin to spar can be seen as a dark blue region corresponding to a greater thickness.
- The drilled hole presents itself as a near-surface circular indication in the thickness C-scan (green box) as there is no clear back wall reflection (dark circle in amplitude C-scan and discontinuity in the back wall in B-scan).

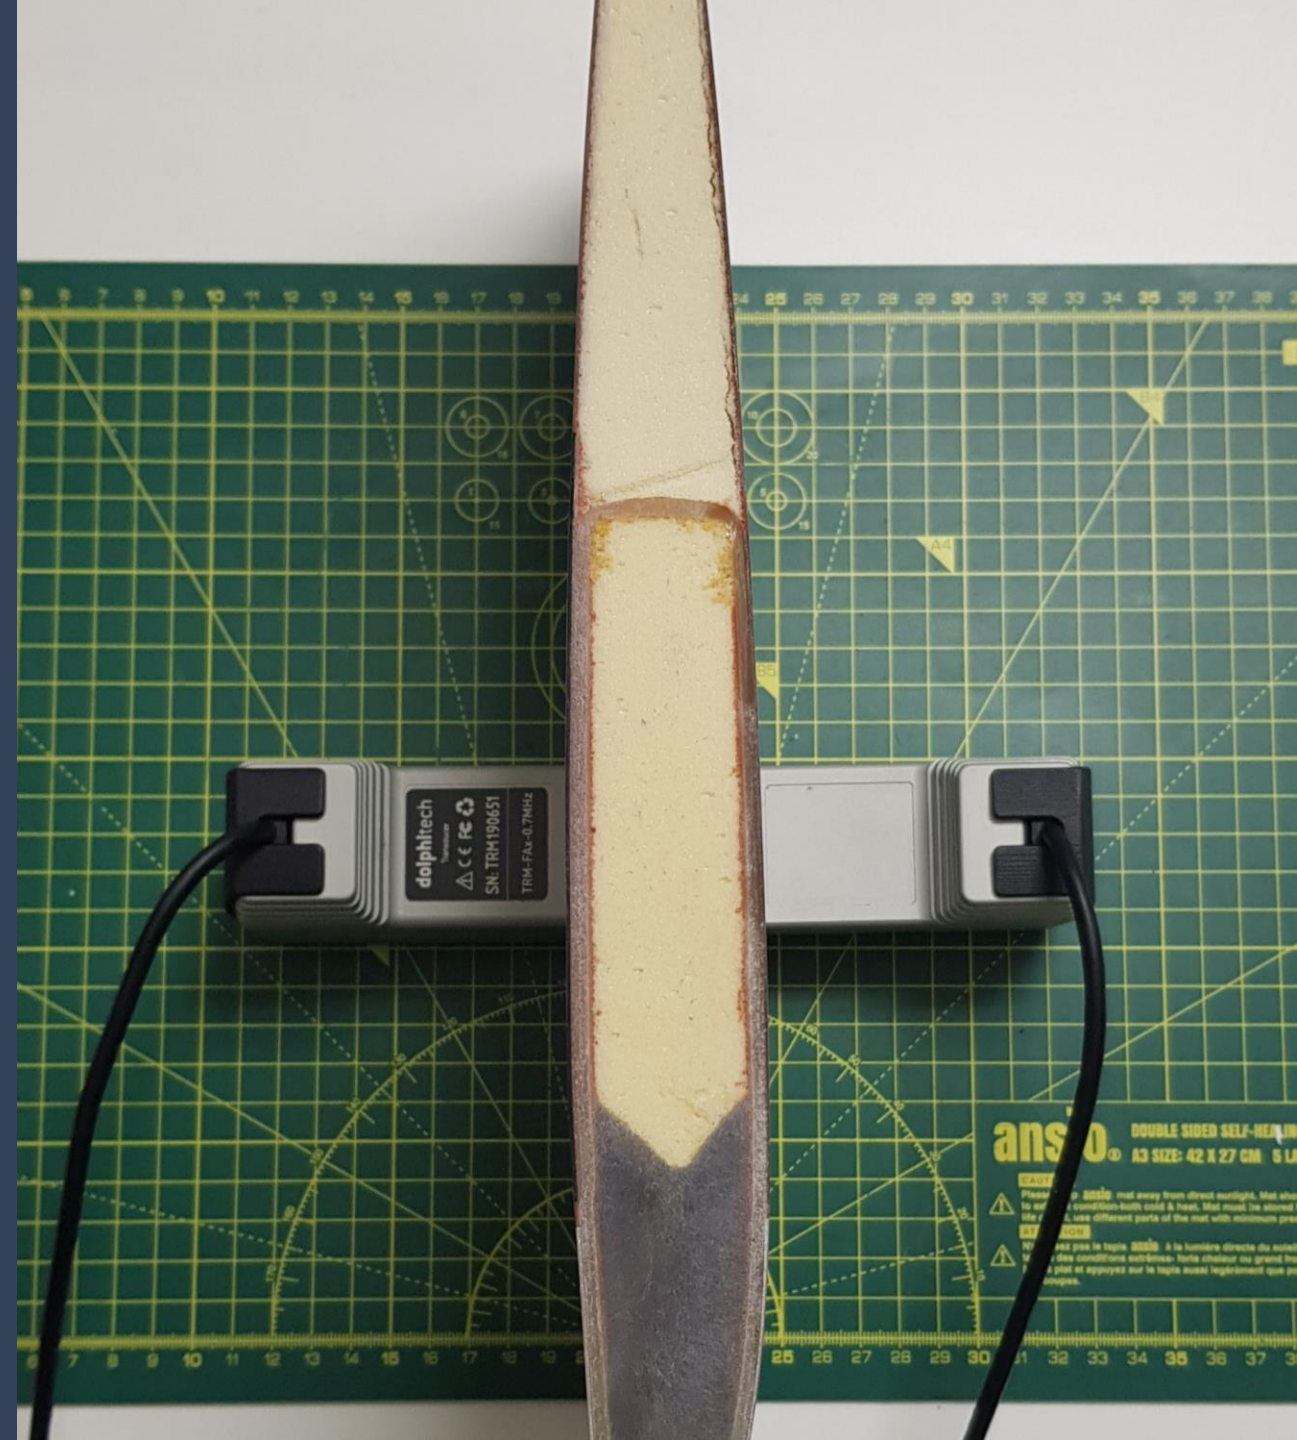
- To penetrate through the foam core, through-transmission ultrasound (TTU) needs to be used.
- Our version of this is called MxTTU, which is a matrix array implementation of TTU.
- The sample was tested with both a 0.7 MHz pair of transducers and a 1.5 MHz pair. The 0.7MHz pair were found to produce better results so results from these scans are shown.
- Some scans from individual locations are shown, along with a manually-stitched scan
- Manually-stitched scans are formed by freehand positioning the transducer with the data from each location being stitched together

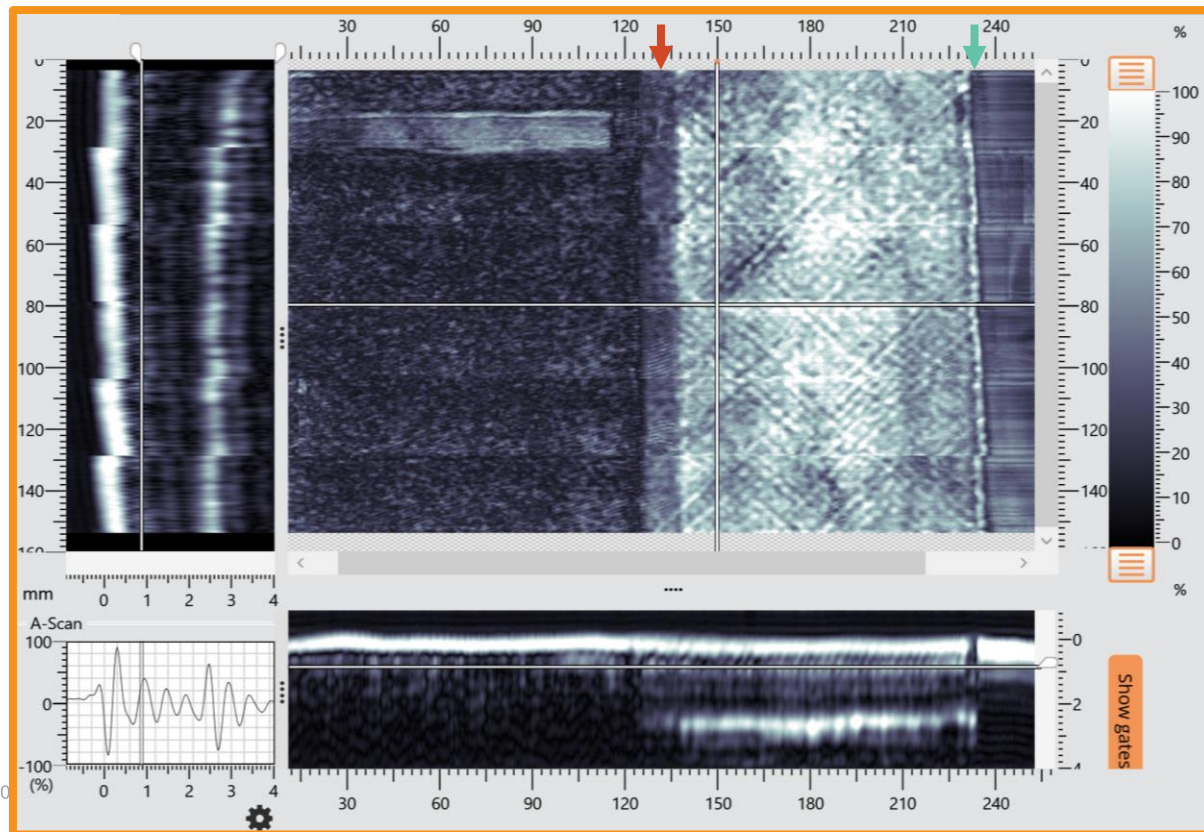
# Results: Encoded map

- Shown is an encoded map covering the top surface of the sample.
- The encoded map is shown in amplitude view, but the thickness (ToF) data is simultaneously acquired and will be shown on the next slide.
- The  $+45/-45^\circ$  plies in the thicker spar section can be clearly resolved, As can the texture change between the thin GFRP, thicker GFRP and leading edge metal region.

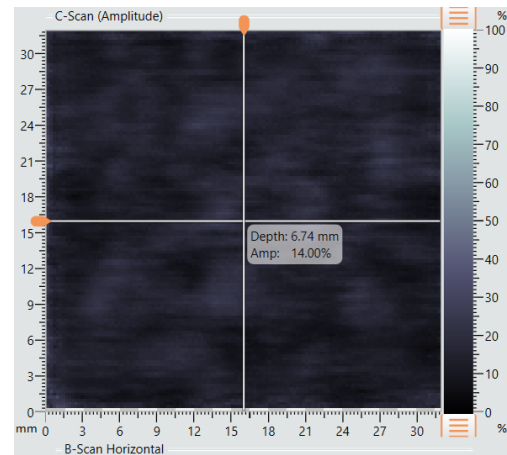
50% vacuum

14.0% amplitude

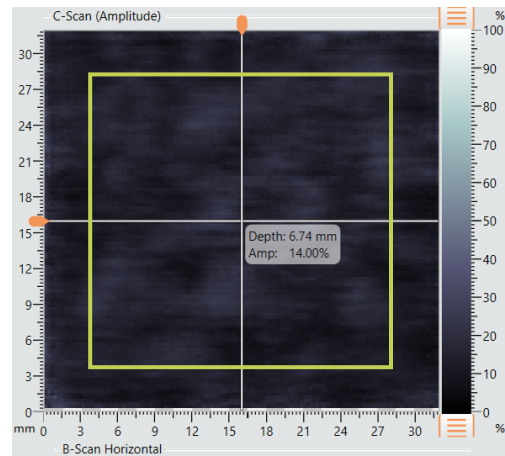
50% vacuum

- Next level of analysis:
  - Statistical measurement over region of interest
  - This represents values from 10,000 A-scan (25 x 25mm measurement square)

Statistics		
Mean	Median	Mode
16.12 %	16.10 %	16.50 %
Std. Deviation	Maximum	Minimum
3.53 %	28.90 %	6.07 %

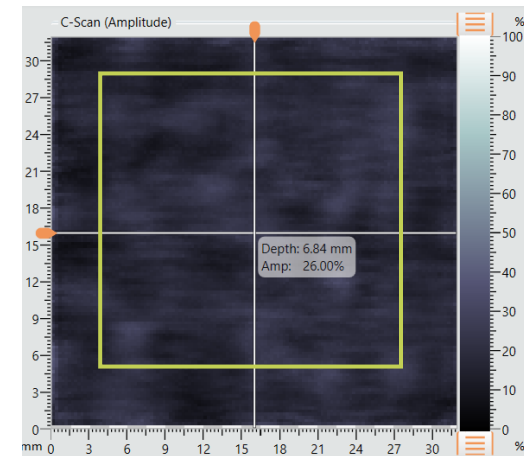
75% vacuum

Statistics		
Mean	Median	Mode
19.77 %	19.70 %	19.70 %
Std. Deviation	Maximum	Minimum
3.80 %	34.04 %	8.51 %

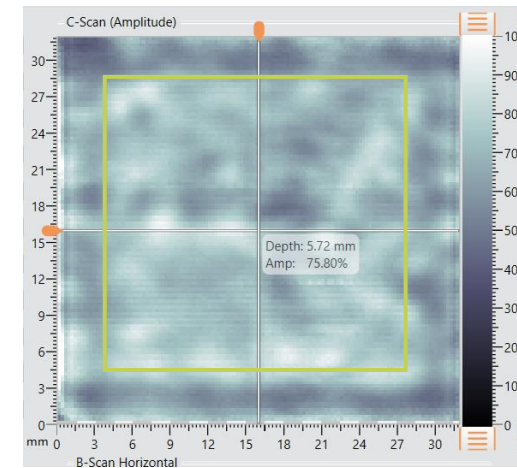
100% vacuum

- Final level of analysis:
  - Defect detection tool used over measurement square
  - This applies a threshold amplitude value to the scan data

Defect		
Height	Width	Area
0.00 mm	0.00 mm	0.00 mm <sup>2</sup>
Mean	Median	Mode
NaN %	NaN %	NaN %
Std. Deviation	Maximum	Minimum
NaN %	NaN %	NaN %

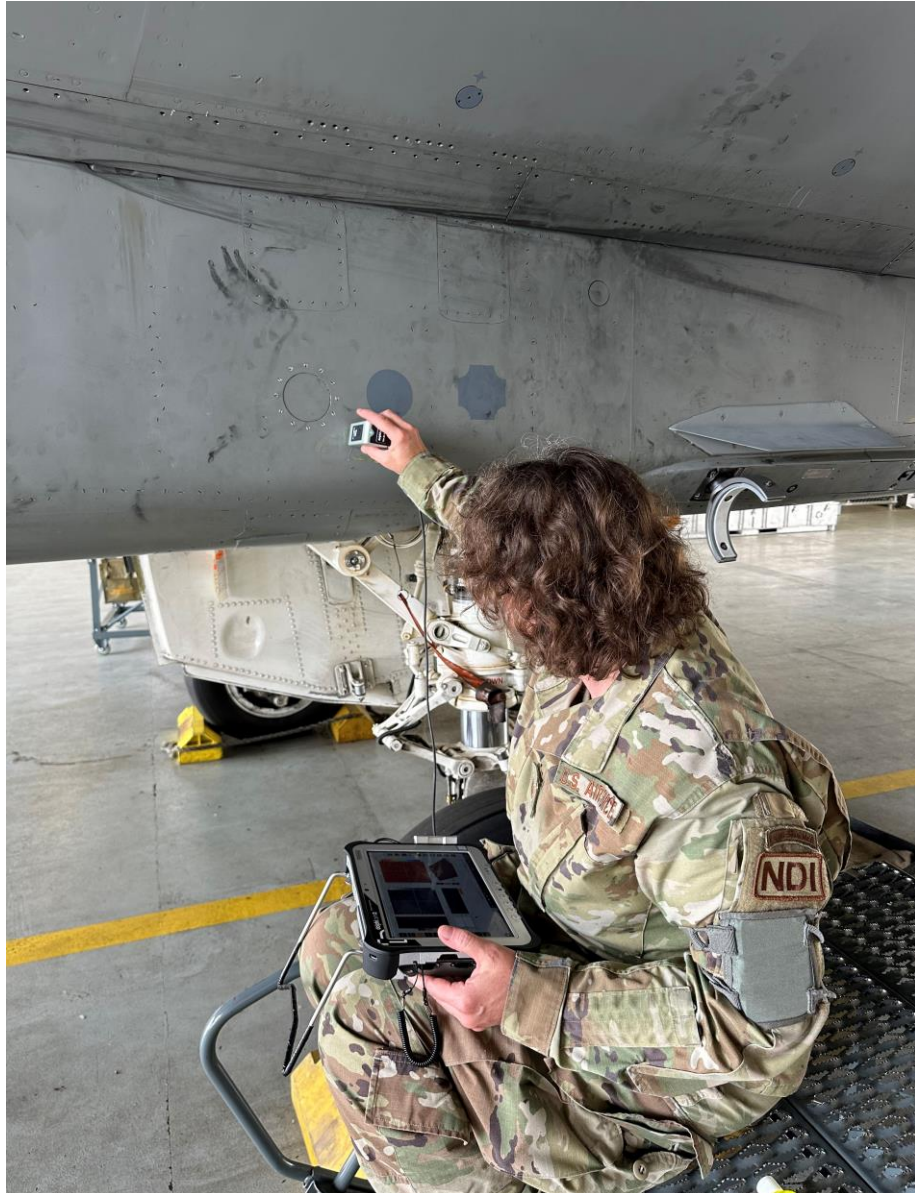
Simple to operate, no expert required, due to pre-configured files per aircraft type

Detecting damage: Battle /impact/ overstress/ weather/lightning/accidental

- Preset file loaded to dolphicom2
- Material has damage in it, with a threshold set for tolerance
- Anything “appearing” on the scan is outside acceptable tolerance
- Auto defect detection mode also shown
