CHEMICAL DEPARTMENT OF COMPOSITES: Summary of Phases 1-3 Work and Final Phase 4 Work 2 April 2024

Ryan McGill, Alexander B. Morgan
Structural Materials Division
University of Dayton Research Institute

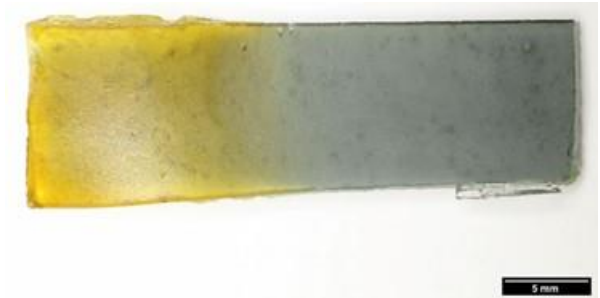
- B&B Tritech 9095 Chemical Stripper, while relatively benign for stripping metal substrates, has some effects on aerospace grade epoxies.
 - Significant degradation of thermal, chemical, and mechanical properties with EA9396 epoxy, even after 8 hour exposure.
 - Decomposition of EA9396 epoxy (chemical incompatibility) with 72 hour or longer exposure times. Severe decomposition at 8 weeks.
 - Some minor effects on thermal, chemical, and mechanical properties with 7714A and 977-3 epoxies after 8 hours, more notable effects after 72 hours. Severe degradation of properties with prolonged exposure (4-8 weeks).
 - Ranking of chemical stripper “resistance”:
 - 977-3 > 7714A > EA9396
- Phase 1 reports available through ACO.

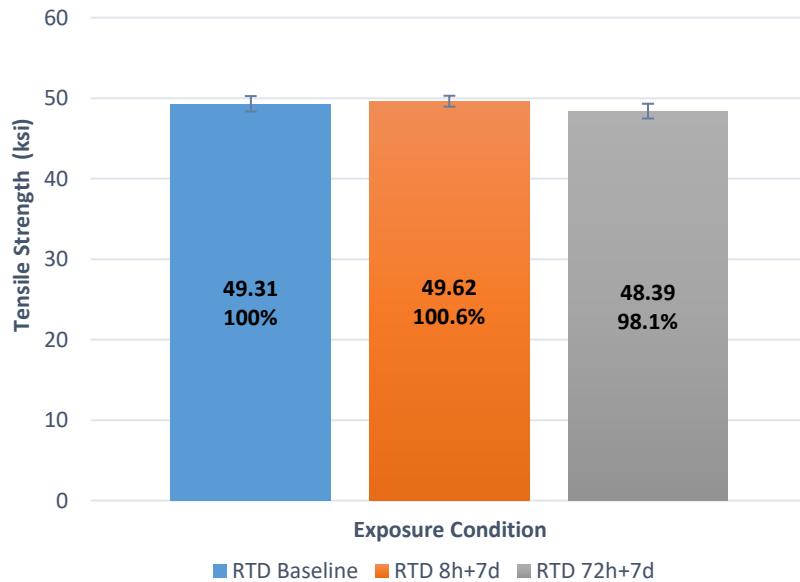
F155 RTD Tensile Strength vs Exposure Condition

- **Insignificant Decreases to Tensile Strength and Modulus**
- **Tests were only conducted at room temp on dry specimens**

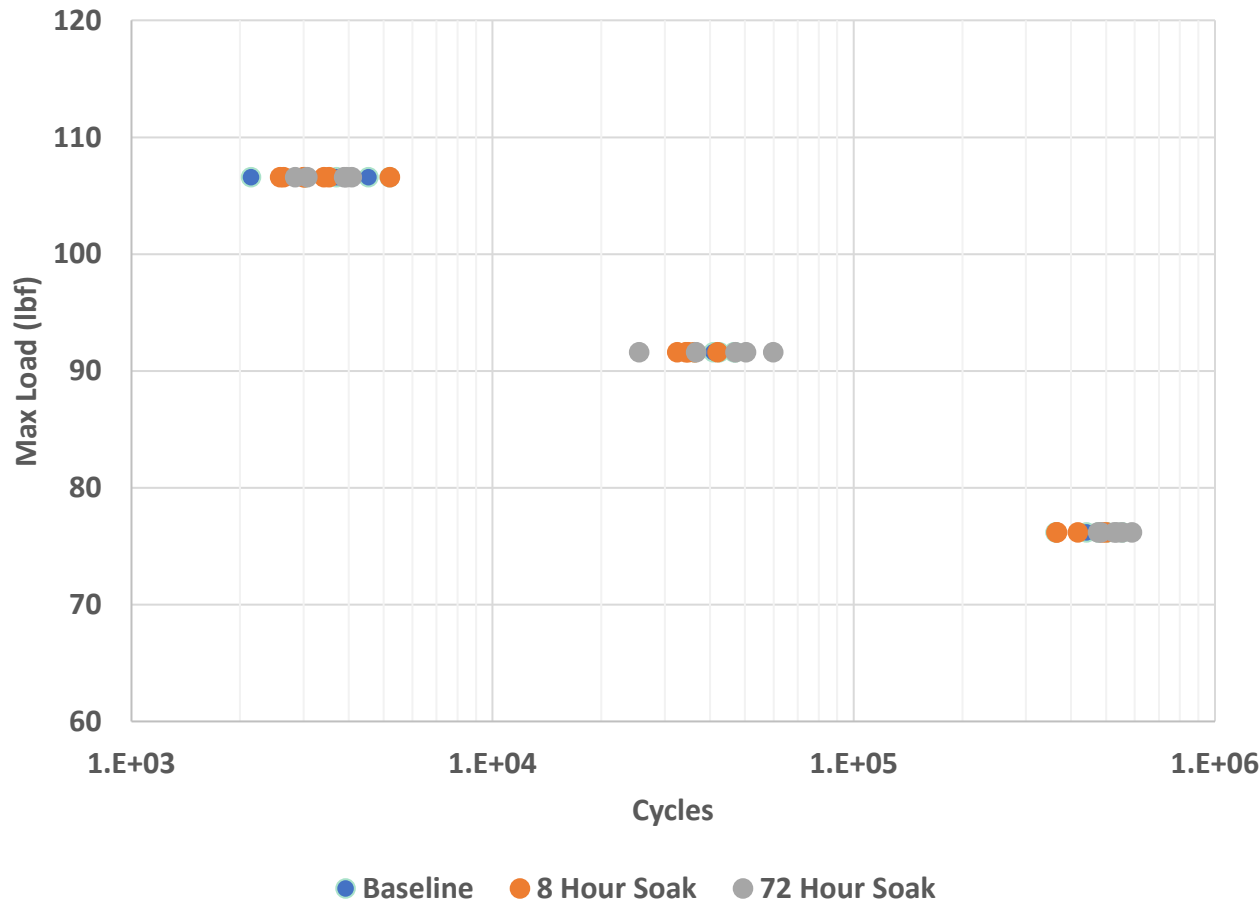
F155 Flexure Fatigue Load vs Cycles

- **5 Specimens tested for each exposure condition and each load level**
- **No noticeable effect on fatigue life from the chemical stripper**

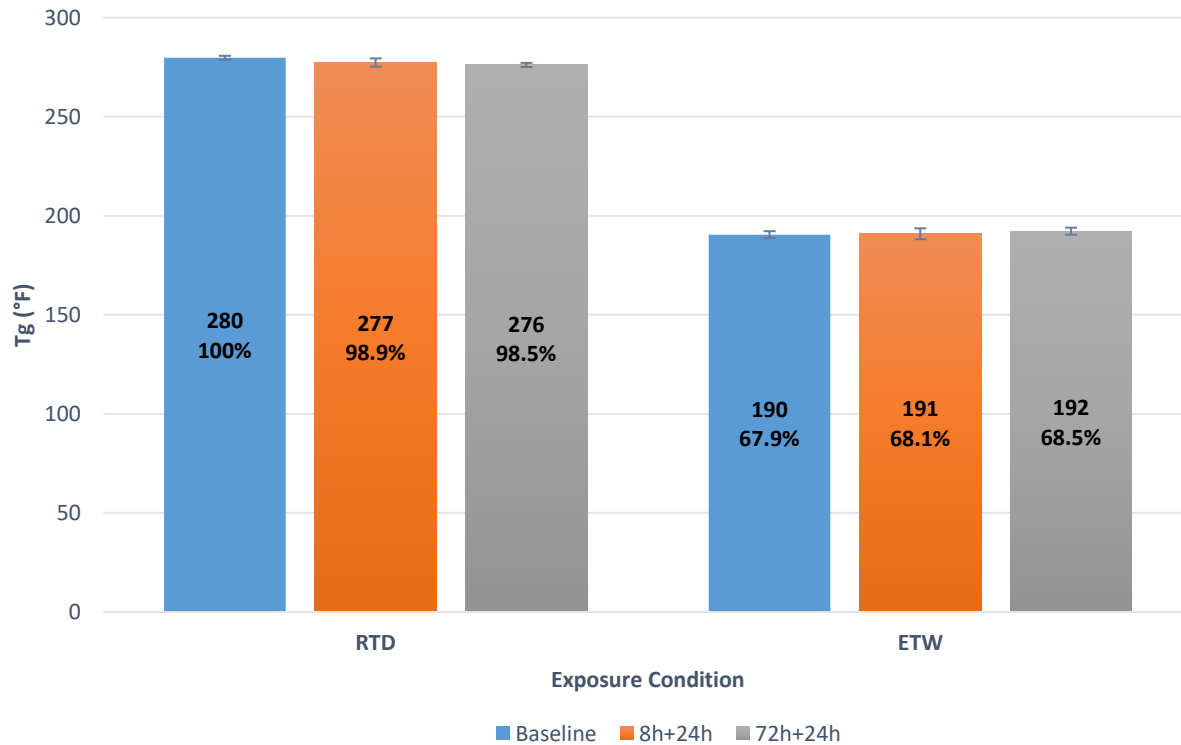
F155 T_g via DMA vs Exposure Condition and Environmental Conditioning
With Percentage of RTD Baseline

- **ETW specimens conditioned for 1200 hours at 160°F 85% RH before chemical exposure**
- **Insignificant change from chemical exposure in both RTD and ETW conditions**
- **Humidity conditioning caused large drop in T_g , any effect of chemical stripper is minimal compared to the drop between dry and wet T_g**

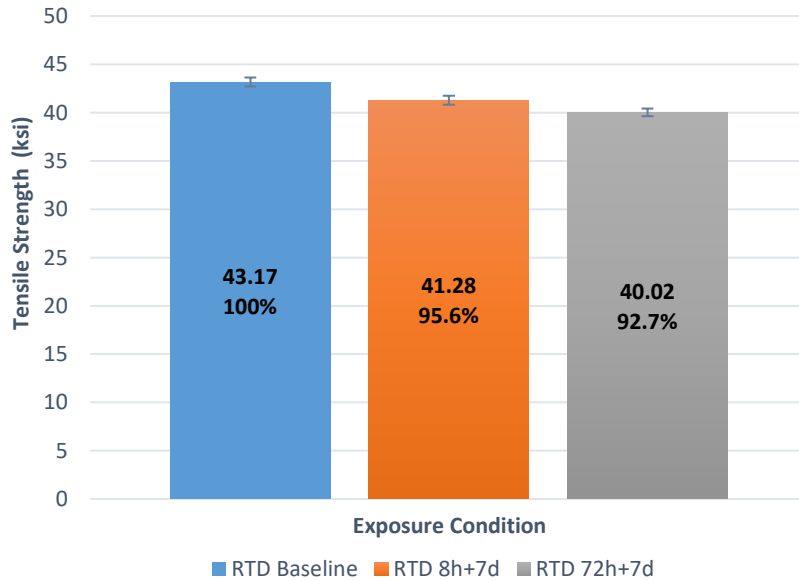
F161 RTD Tensile Strength vs Exposure Condition

- **Small Decreases to Tensile Strength and Modulus**
- **Tests were only conducted at room temp on dry specimens**

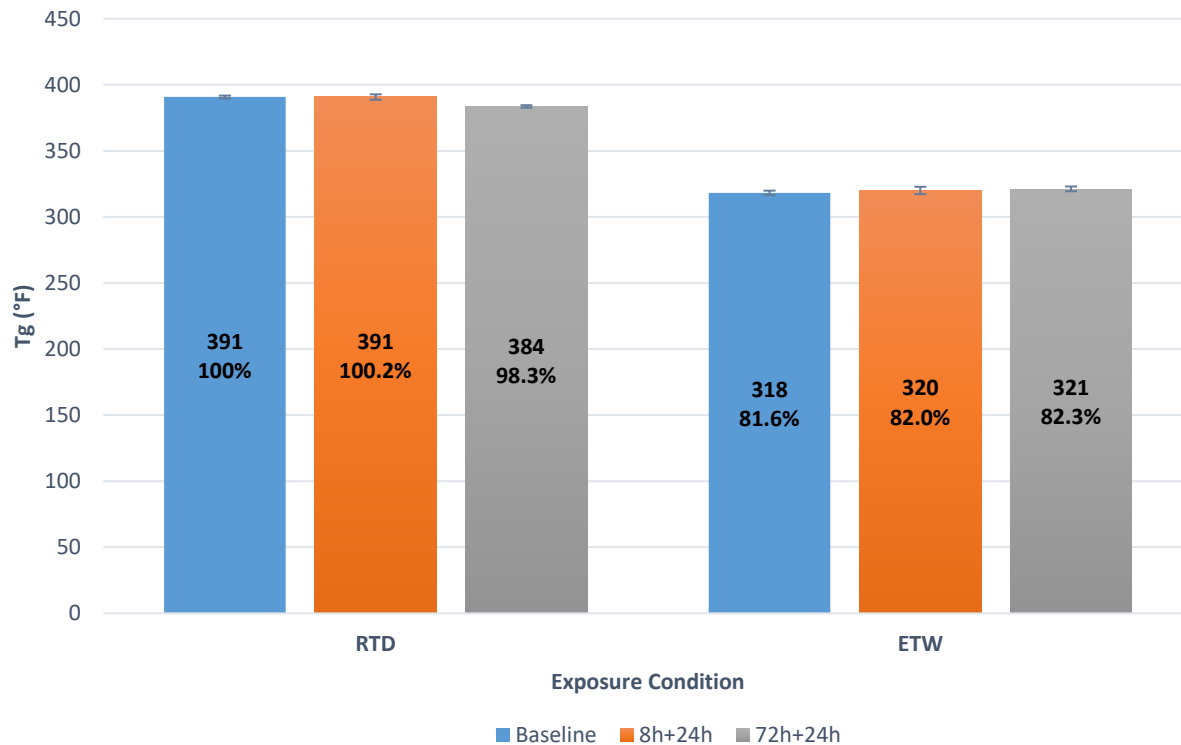
F161 T_g via DMA vs Exposure Condition and Environmental Conditioning
With Percentage of RTD Baseline

- ETW specimens conditioned for 1200 hours at 160°F 85% RH before chemical exposure
- Insignificant change from chemical exposure in both RTD and ETW conditions
- Humidity conditioning caused large drop in T_g, any effect of chemical stripper is minimal compared to the drop between dry and wet T_g

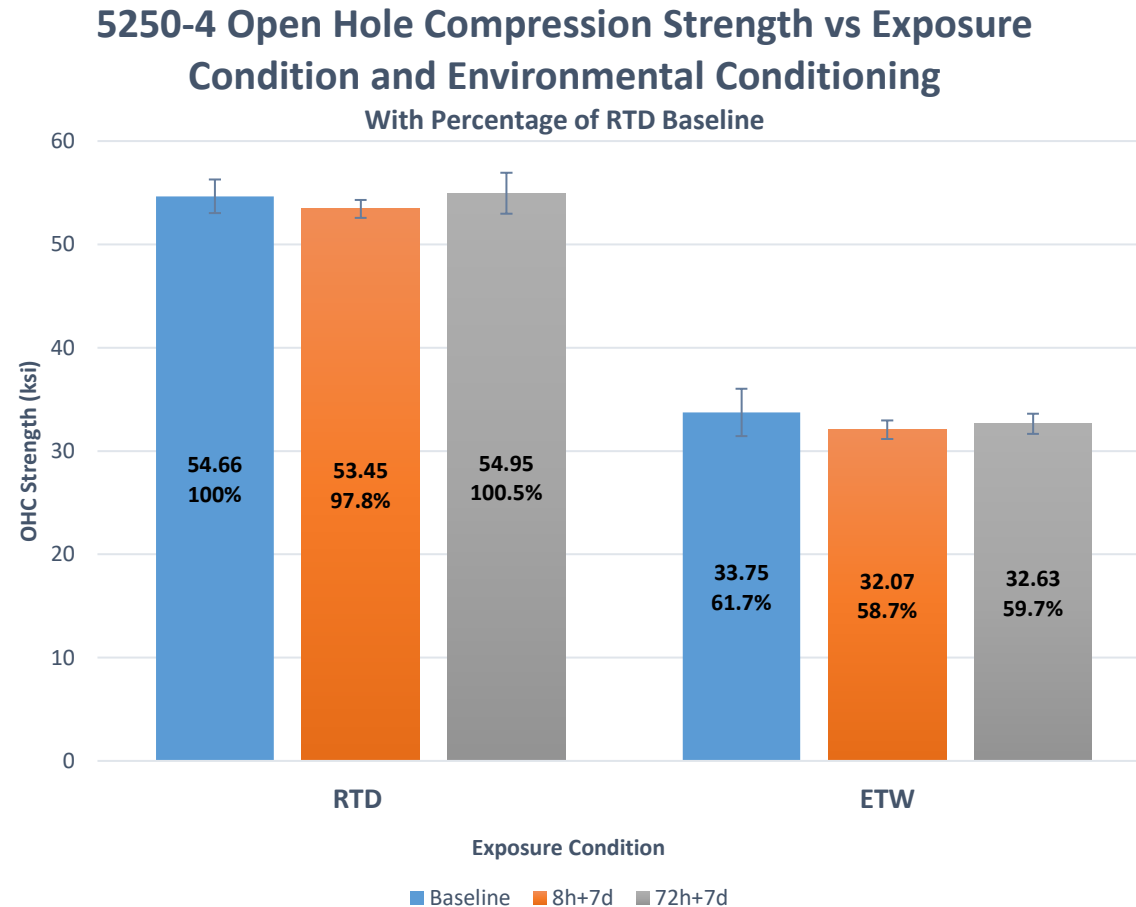
Phase 4 Results: 5250-4 + Carbon Fiber Open Hole Compression (ASTM D6484)

- ETW specimens conditioned for 1200 hours at 160°F 85% RH before chemical exposure
- ETW Specimens were tested at 385°F based on the baseline wet T_g results from DMA testing
- Insignificant change from chemical exposure
- **Humidity conditioning + elevated test temp caused very large decrease to Open Hole Compression properties**
